Kitemark Testing of Building Aperture Products

Kayron - Large Barrier - Test results

MCM7924-RT008-R02-00

November 2017

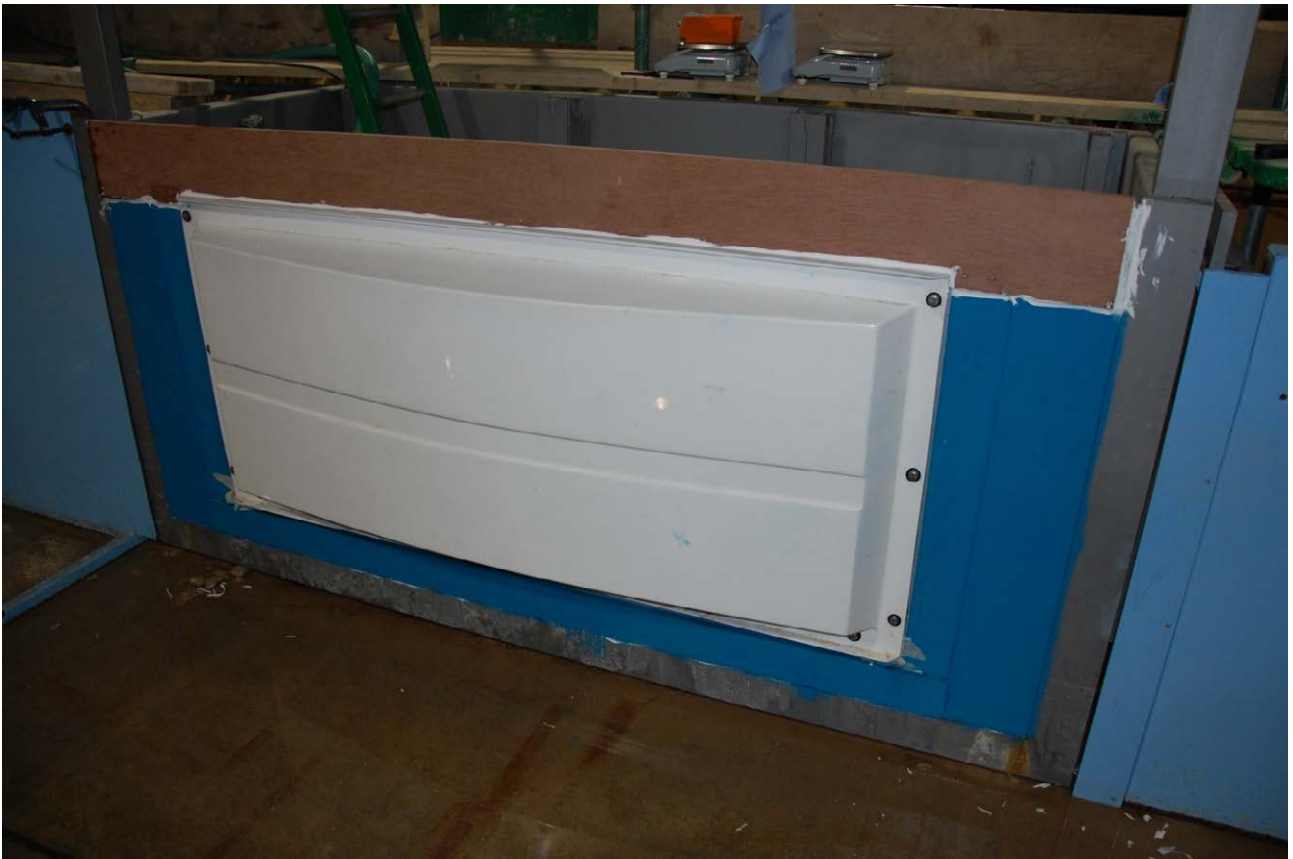
Figure 1.1: The Kayron flood barrier in the HR Wallingford test rig.

The product is an externally fitted flood barrier which was provided and fitted by Kayron. The product consists of a solid fibreglass structure fitted to the outside of the building, as shown in Figure 1.1. A number of metal screws attach the product over the building aperture and fitting into several previously inserted threaded 'rivnuts' as shown in Figure 1.2

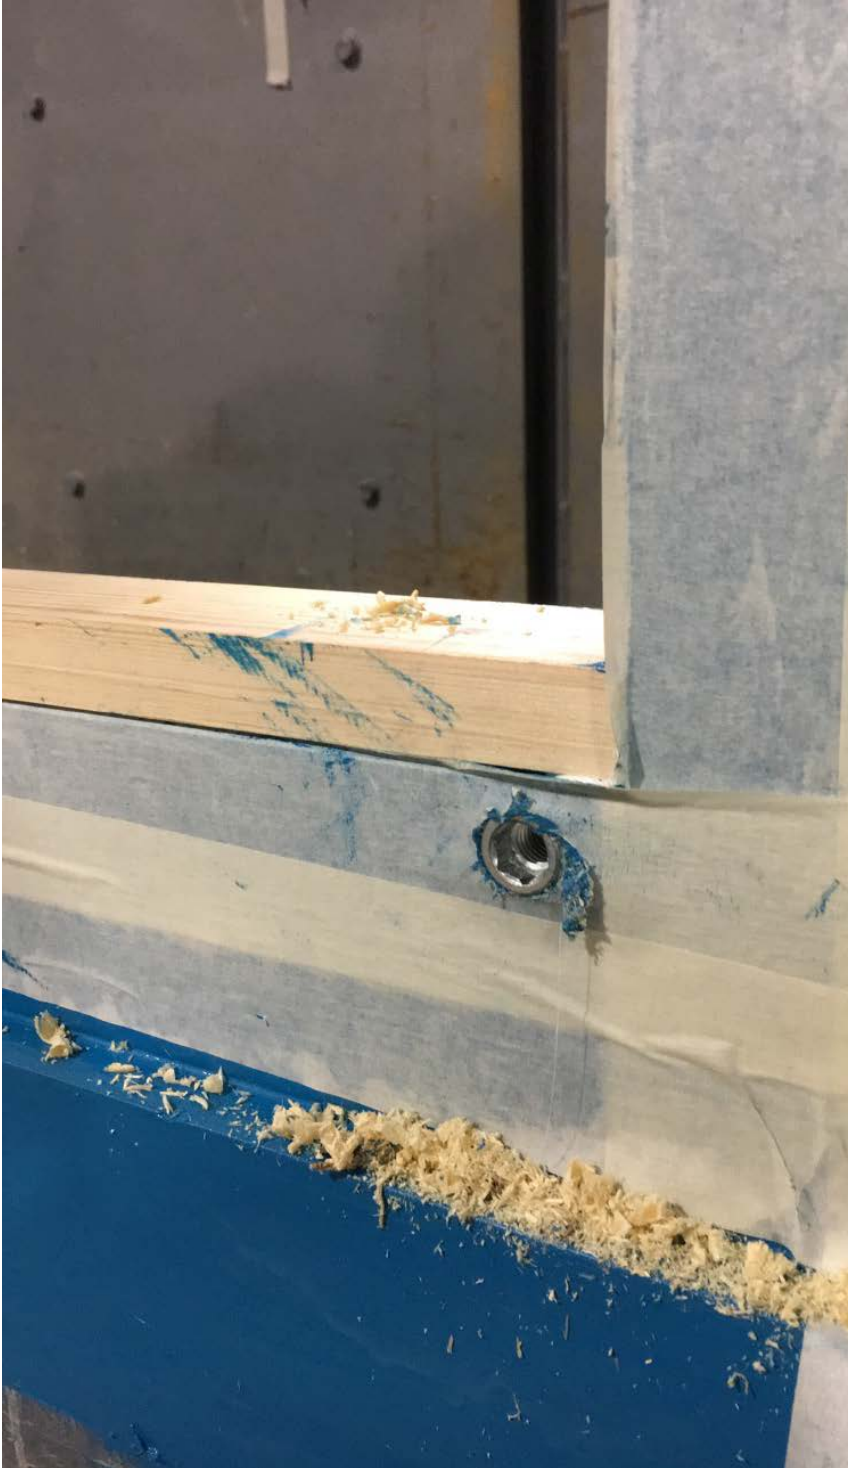
Figure 1.2: Threaded 'rivnuts' used to mount product to frame.

1. In real-world use, holes are drilled into the outside of the building, however for testing the holes were drilled into a timber frame in the testing rig.
2. A threaded rivnut' was added to each hole to allow screws to be fixed to the frame.
3. The structure is added and attached with the screws until tight.
4. A small sheet of plywood was added to the top of the product to prevent overtopping during wave and current testing Figure 1.4.

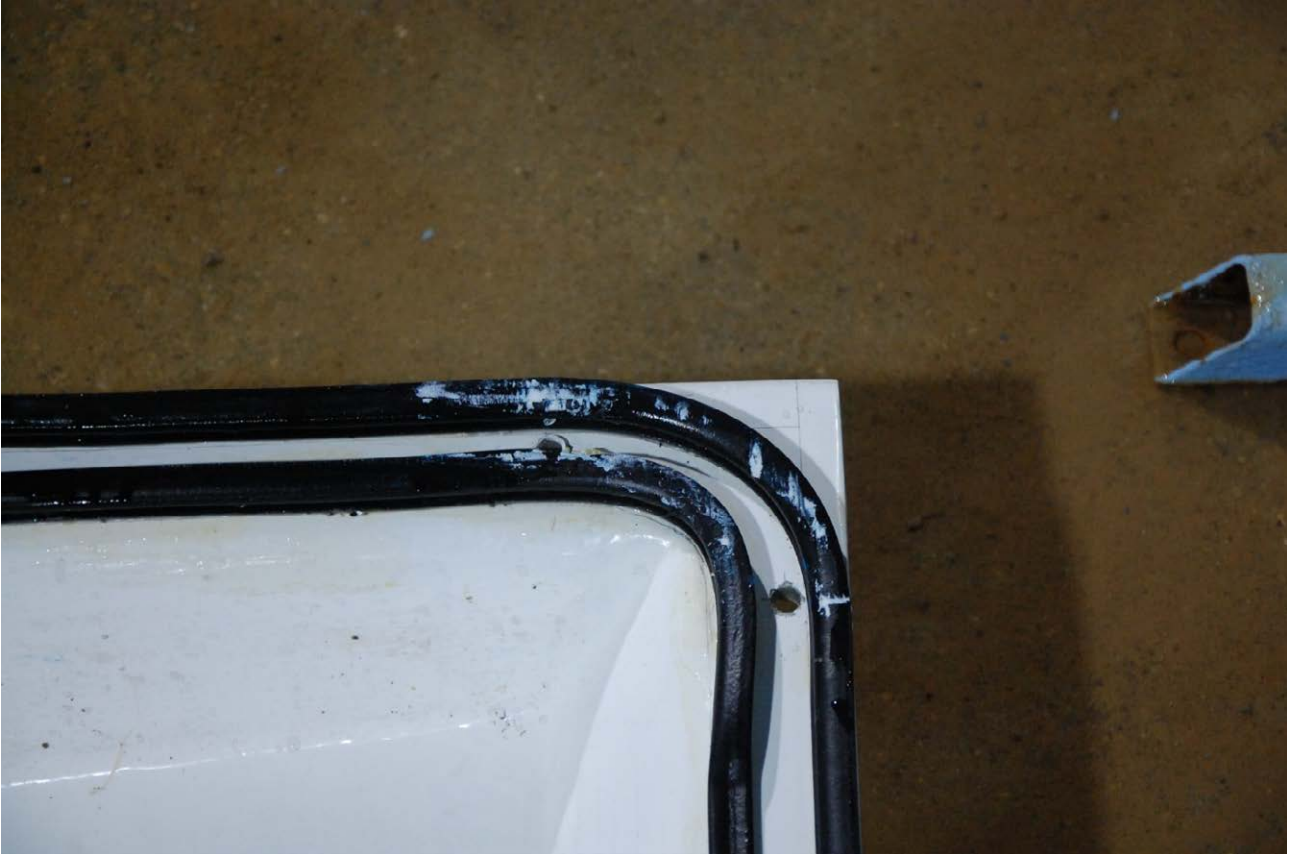
Figure 1.3: The dual seal used in Kayron's Large Flood product which is subsequently attached to a timber frame.

The inner edge of the barrier consisted of a dual seal. The seals were attached to a timber frame allowing for a secure fixture to the building aperture. This meant that any leakage through the barrier could be recorded around the inner seal. The set up for this is shown in Figure 1.3.

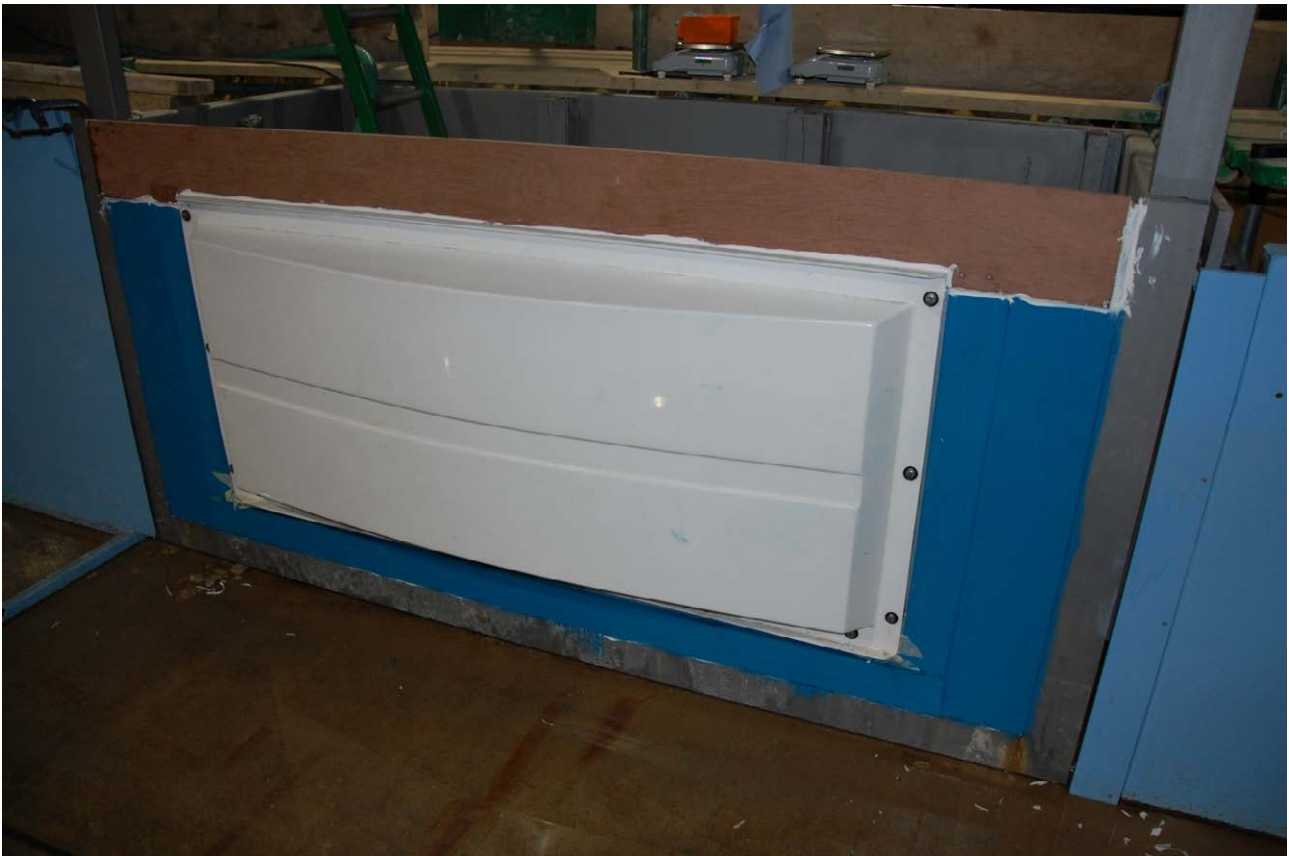
Figure 1.4: Plywood attached above product to prevent overtopping from wave overtopping.

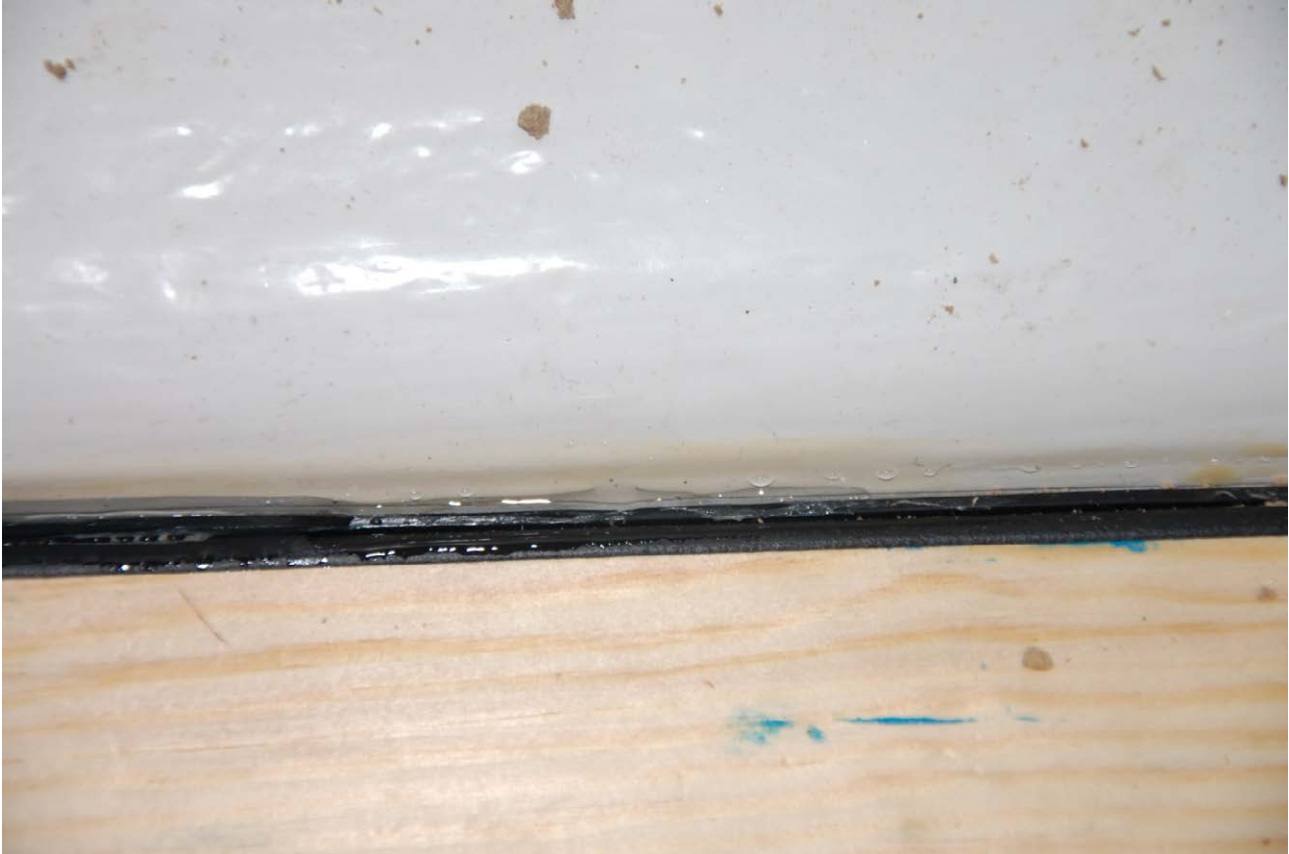
Figure 3.1: Water on seal of product demonstrating low leakage.

The test facility was filled to a depth of 400mm above the invert of the barrier. A total volume of water passing through the seal of 0.009 litres gave a leakage rate of 0.005 l/h/m (an aperture width of 1.780m was measured for this product) so the product was successful in meeting the requirements for this test. A photograph for this test demonstrating water on the seal of the product is shown in Figure 3.1. As the leakage rate was so small, it was recorded by weight through mopping up the water on the seal.

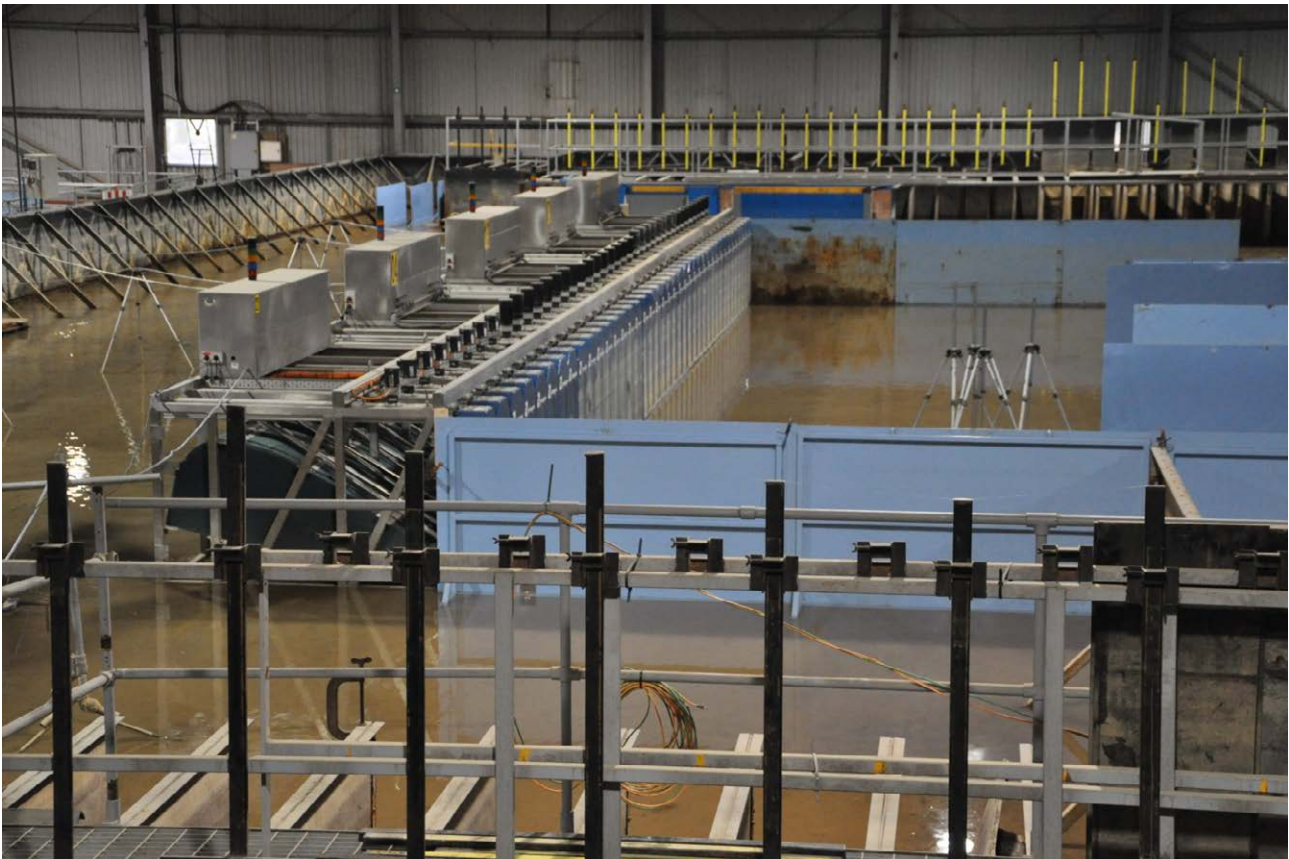
Figure 3.2: HR Wallingford wave generator.

The wave leakage tests were performed with one of HR Wallingford's multi-element paddles. HR Wallingford's software (HR Merlin) was used to control the paddles and the wave data was recorded using an array of four calibrated twin-wire wave gauges which measured changes in the surface elevation of the water. These measurements were recorded using HR DAQ software, which is capable of calculating wave information such as mean wave period and significant wave height. An overall view of the wave generator is shown in Figure 3.2.

Waves were measured by recording the average significant wave height at each of the four wave gauges, this was then adjusted using a reflection coefficient, calculated by the software, to generate the incident significant wave height.

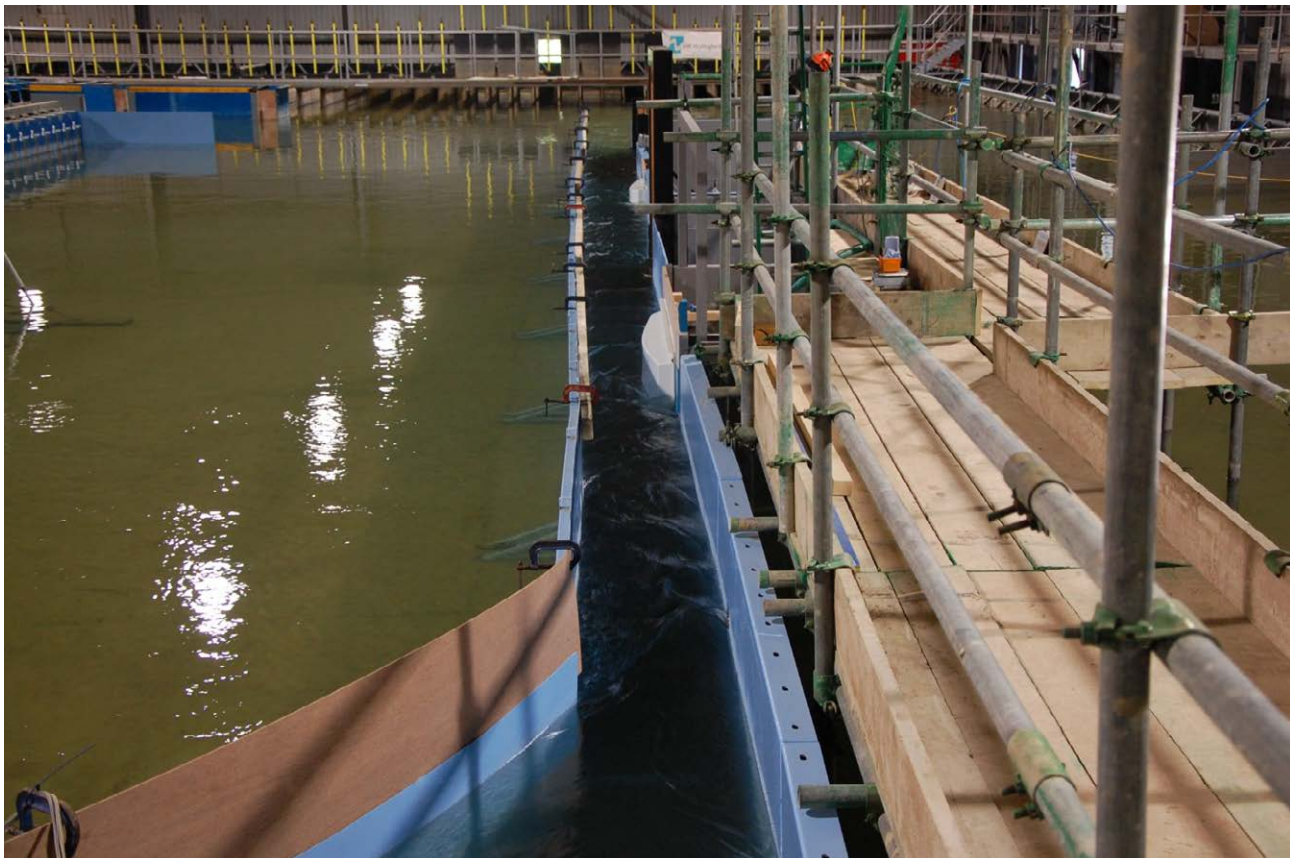
Figure 3.3: Current testing setup showing wave guide positions and flow direction.

To control the flow, guides were installed between the pump outlet and the test specimen to form a channel for the water to flow through. Several of the guides previously used to control the waves in front of the product were used to create the necessary channel in front of the product as can be seen in Figure 3.3 and Figure 3.4.

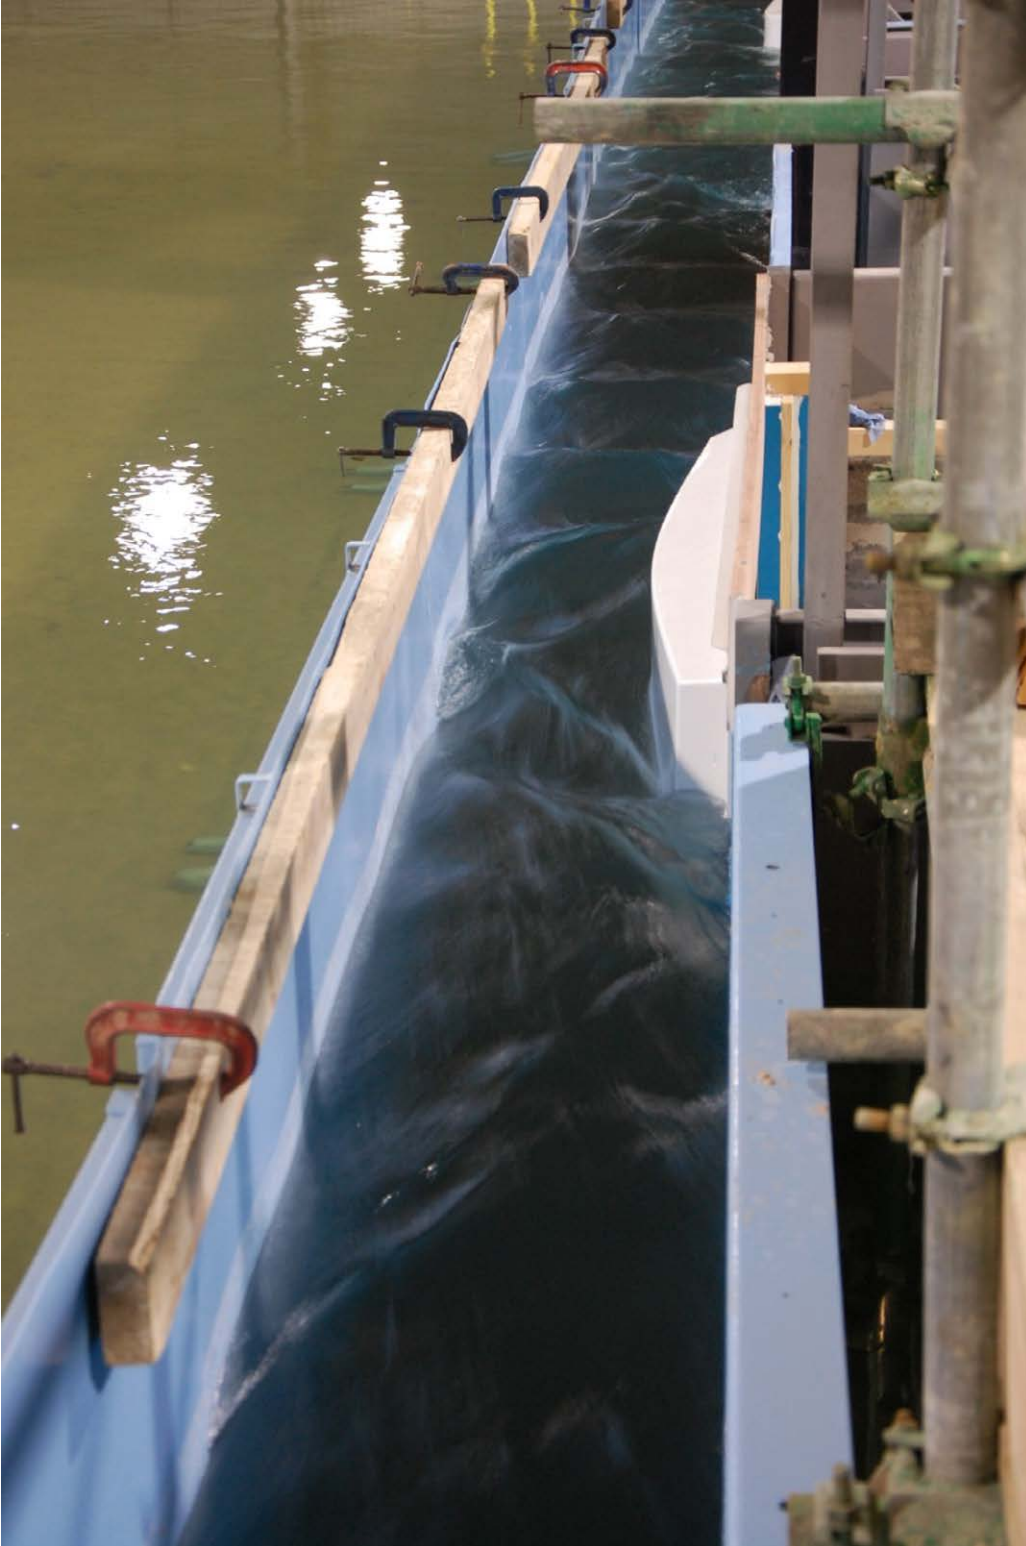
Figure 3.4: View downstream during current testing.
